**DEPARTMENT OF TRANSPORTATION**

Contract #: 04-0120F4Cty: SF/ALA Rte: 80 PM: 13.2/13.9File #: 69.28**WELDING INSPECTION REPORT****Resident Engineer:**Siegenthaler, Peter**Address:** 333 Burma Road**City:** Oakland, CA 94607**Report No:** WIR-021789**Date Inspected:** 13-Mar-2011**Project Name:** SAS Superstructure**OSM Arrival Time:** 700**Prime Contractor:** American Bridge/Fluor Enterprises, a JV**OSM Departure Time:** 1900**Contractor:** Zhenhua Port Machinery Company, Ltd (ZPMC), Changxing Island **Location:** Shanghai, China**CWI Name:** Li Yang and Zhu Zhong Hai**CWI Present:** Yes No**Inspected CWI report:** Yes No N/A**Rod Oven in Use:** Yes No N/A**Electrode to specification:** Yes No N/A**Weld Procedures Followed:** Yes No N/A**Qualified Welders:** Yes No N/A**Verified Joint Fit-up:** Yes No N/A**Approved Drawings:** Yes No N/A**Approved WPS:** Yes No N/A**Delayed / Cancelled:** Yes No N/A**Bridge No:** 34-0006**Component:** OBG Trial Assembly**Summary of Items Observed:**

Orthotropic Box Girder (OBG) at Trial Assembly Areas

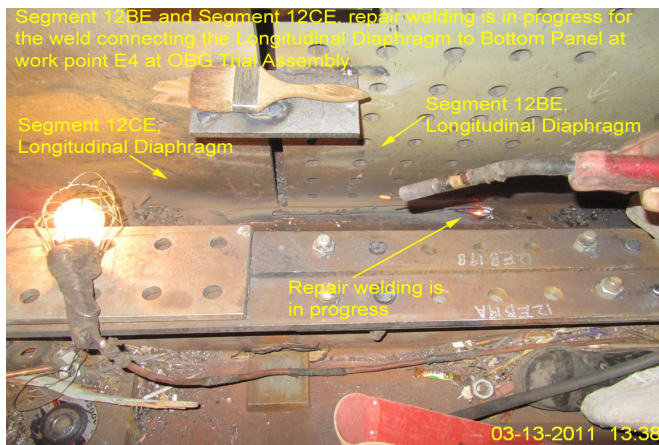
This QA Inspector observed the repair welding by Flux Cored Arc Welding (FCAW) process on a Complete Joint Penetration (CJP) groove weld. The Weld joint was designated as Seg3003S-035. The welder identification was 040367 and was observed welding in the 2G (Horizontal) position using approved Welding Procedure Specification WPS-345-FCAW-2G(2F)-ESAB-Repair. The piece mark was identified as weld connecting Longitudinal Diaphragm to Bottom Panel at work point E4. ZPMC performed repair welding in accordance with Welding Repair Report B-WR20266.
